# BEAVER CREEK BRIDGE CRUDE OIL SPILL

## GLASGOW, KY - REGION IV

U.S. ENVIRONMENTAL PROTECTION AGENCY  
 POLLUTION/SITUATION REPORT  
 Beaver Creek Bridge Crude Oil Spill - Removal Polrep  
 Initial Removal Polrep

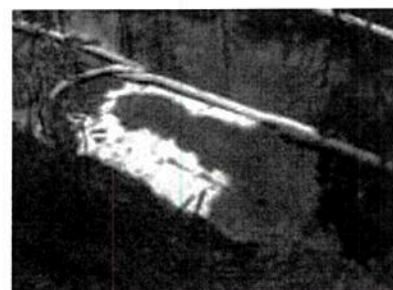
Description: Post well plugging photo of creek bank

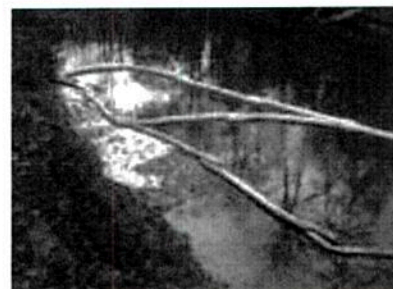
Description: Impression block dropped on Thurs Oct 2nd showing impression of 2" coupling in upper right corner of wax block.

Thursday afternoon, a well logging service contractor, Southern Well Wireline Services was brought in and the depth to the obstruction was determined to be 194 feet. 7" casing was evident on the cement bond log to a depth of 144 feet and a seven inch cast iron bridge plug was placed on a casing collar at 124 feet. Good cement was noted behind the casing so no casing perforations were done. After placing the cast iron bridge plug, the flow of crude oil to the surface casing level appeared to stop.

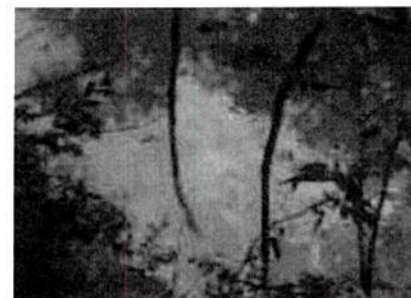
Description: Placement of boom near point source along left descending bank one half mile upgradient of Beaver Creek Bridge.
